Infrared Inspections on Electric Panels without Removing Covers: Can the Inspection be Completed Correctly?

*Joe Gierlach, Director, Technical Training and Support, TEGG Corporation
Joe DeMonte Senior Thermography Course Instructor*

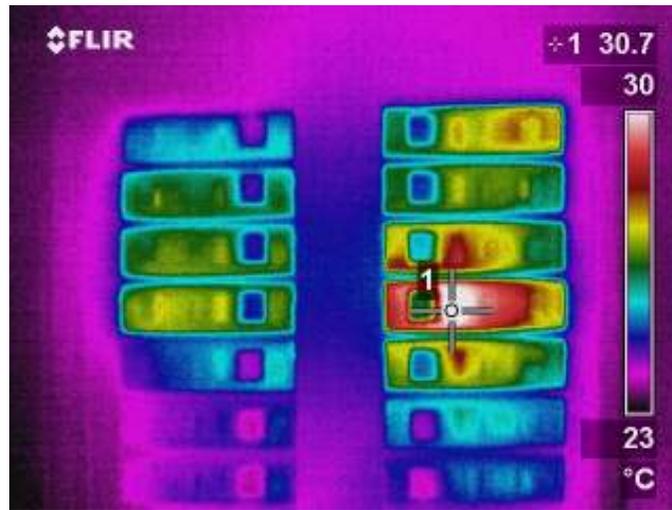
FIGURE #1

As you can see in Figure #1 prior to the removal of the dead front cover, there is an obvious load on the suspect breaker 4th down on the right.

The observed temperature is around 30 degrees C and within the manufacturer's operating specifications. The temperature on the dead front cover is closer to 23 degrees C and not an apparent concern, right? One may simply deduce this is only load created energy on the breaker and bypass it during an inspection.

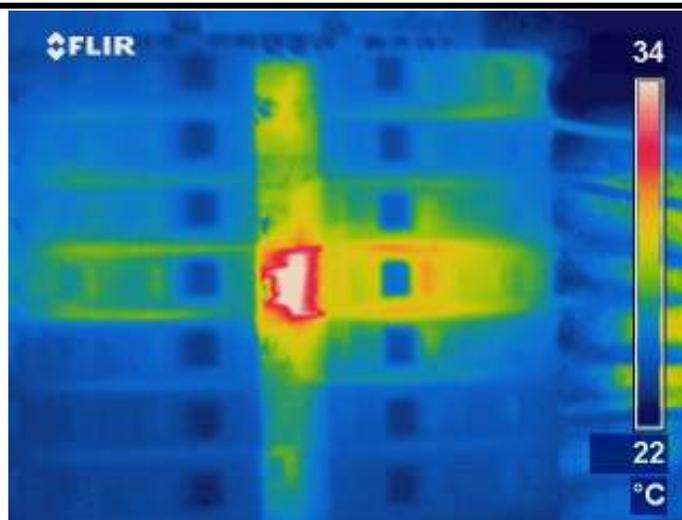
FIGURE #2

Once the cover is removed, a far worse issue is revealed in Figure #2.

- The problem area is centered on the line side connection.
- The actual problem temperature at this light load was approximately 39 degrees C.
- This is an error of nearly 9 degrees C.
- If the cover had not been removed, this more than likely would have been bypassed.
- Any addition of loads would increase the problem temperature exponentially.

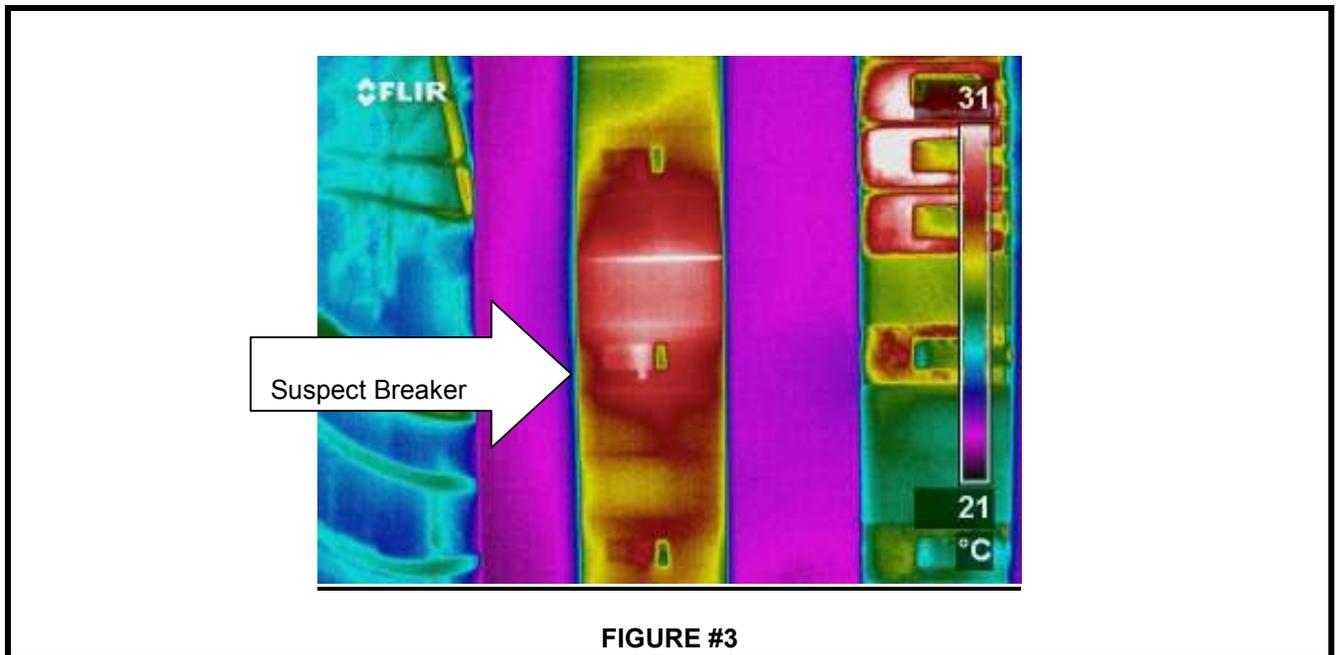
FIGURE #3

- Again, a lightly loaded breaker compared to the rating.
- Around 32 degrees C on the breaker case and well within the manufacturer's specifications for rise over ambient.
- No apparent "deficiency" was observed relating to temperature on the dead front cover, and it was operating at around 22 degrees C, which can be seen by viewing the thermal image in Figure #3.
- But when the cover is removed, a different story is uncovered, as is shown in Figure #4.
- As seen below in Figure #4, the actual problem area again is the bus connection to the breaker.
- But unlike the 22 degrees C observed on the dead front cover, the problem temperature is now running closer to 43 degrees C.
- This is an error of nearly 22 degrees C.

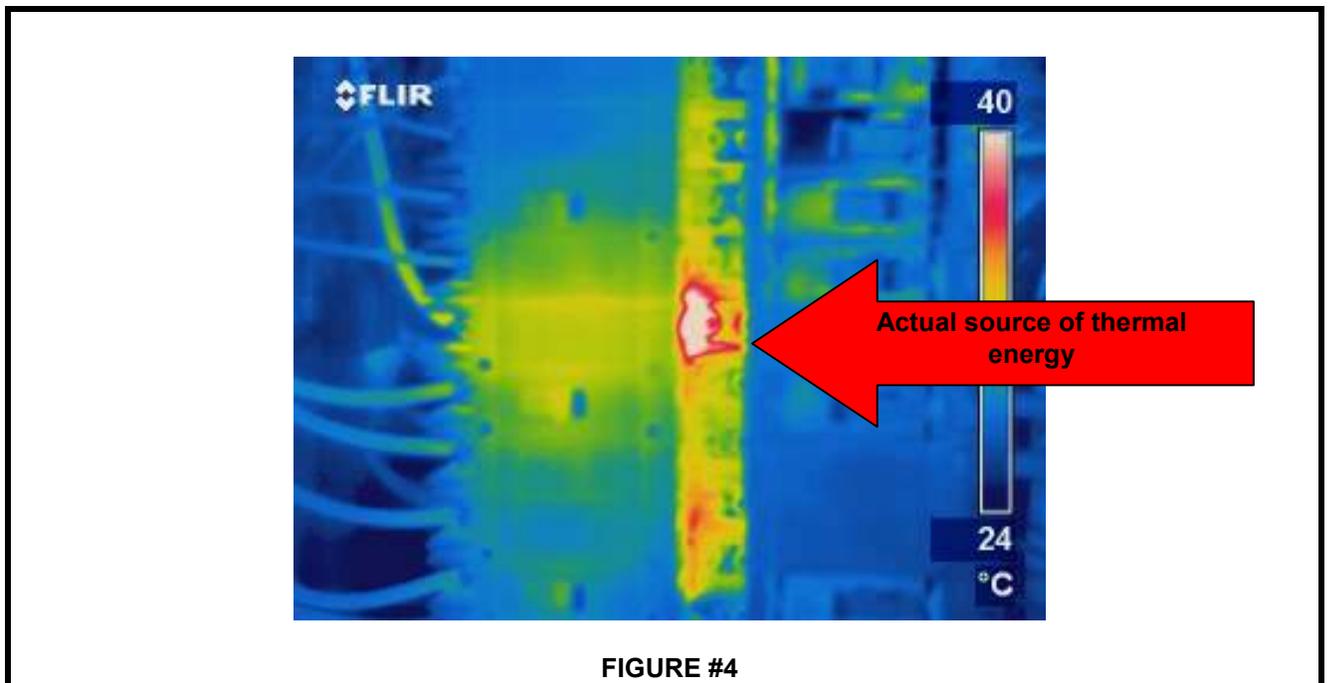
Again, with load demand being light at the time of the survey, increases and the consequences thereof must be considered. This is another clear example of how temperature errors by improper procedure of the technology for the electrical application can occur.

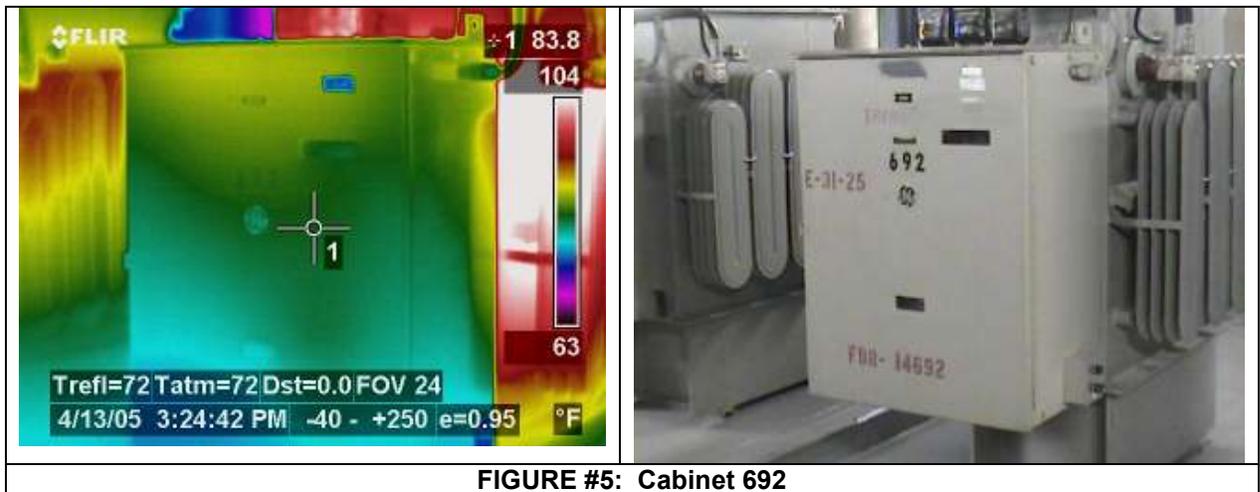
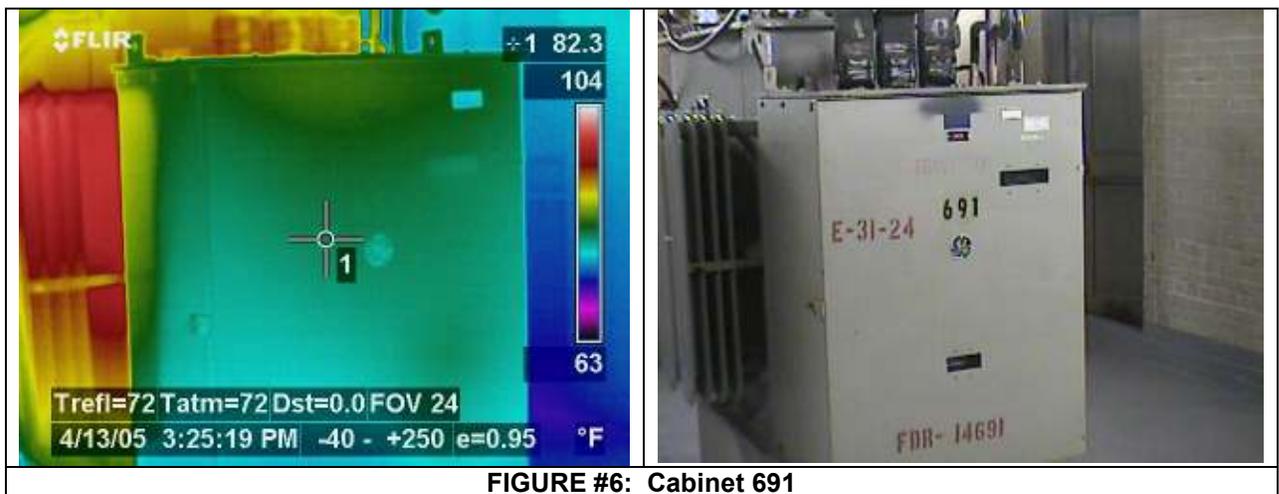
Consider the infrared and visual images shown in Figures #5 and #6. Both show the 480V buss cabinet and connections associated with a 13.2KV to 480V step down transformer. The cabinet in Figure #5 is running approximately 2°F warmer and shows considerable heat towards the top of the cabinet due to convective gains. This would seem to point to a potential issue in the 692 cabinet and no issue in the 691 cabinet. However, upon removal of each of the covers by approved safety measures, we scan with the IR camera again and find the images to be opposite of what we originally thought.

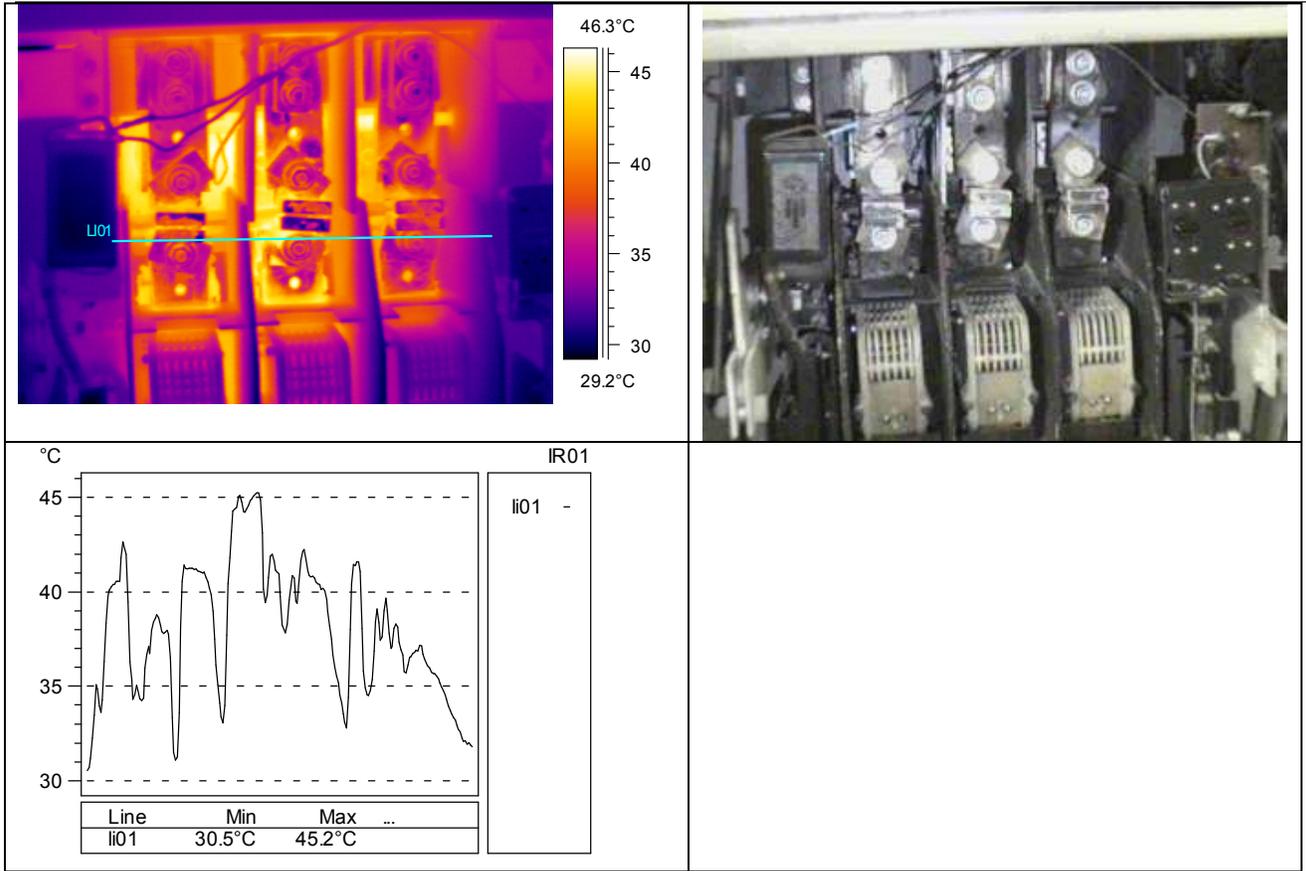
FIGURE #7: Cabinet 692 Opened

The cause of the heat on the warmer 692 cabinet was load related. Cabinet 691 actually had an anomaly that would have gone undetected by not properly removing the cover during the inspection. Also, the fact that this anomaly was found at approximately 10% of the system's rated load shows how a fairly important problem could have been overlooked. Once the load is increased, the heat generated by the fault will increase exponentially. Our calculations would have this rise increase to approximately 110°C when the transformer was under 80% load.

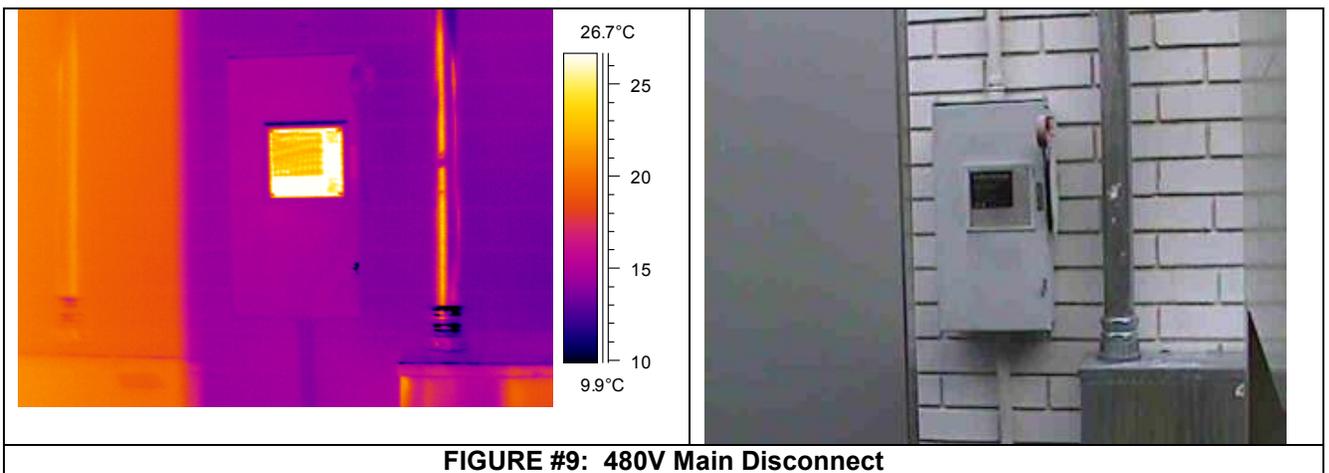
Our next example is of a 480V main disconnect on the outside of a customer's business. As I pointed out earlier in this paper, we took IR images from the outside of the cabinet prior to opening it. Figure #9 shows both the visible and IR images of the cabinet.

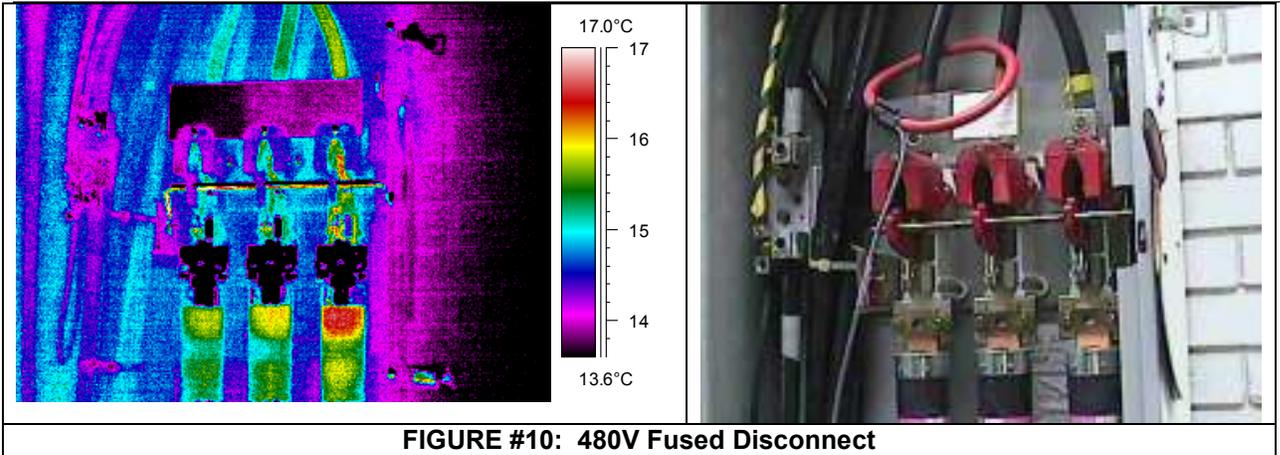
No issues were noted from the outside inspection. We then opened the cabinet using approved safety procedures and scanned the internal fused disconnect to look for suspicious hot spots. The problem would have been missed! Refer to Figure #10 for an infrared image clearly showing a problem on the C phase incoming connection. We needed to open this cover in order to identify it. The C-phase fuse was in need of replacement, so the recommended action was to replace all three with new fuses.

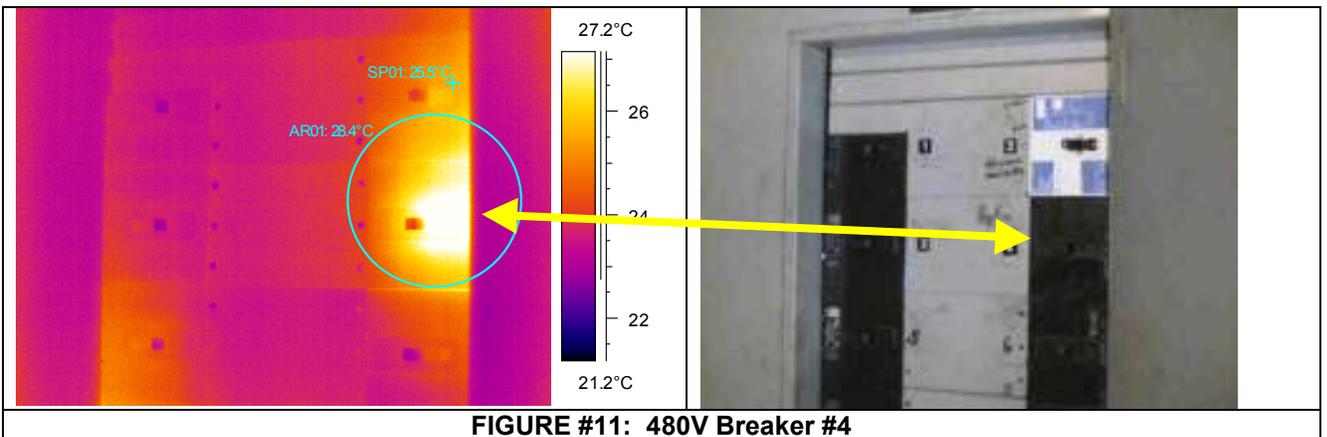
Our next example in this paper is a medium voltage breaker with the dead front cover still in place. We have a minor temperature rise of about 3°C shown on Breaker #4 (see Figure #11).

This infrared image shows that the breaker is a little warm, but not warm enough to warrant further investigation, right? We pulled the dead front cover, again following all safety regulations, to see if there was anything worth reporting to our important customer.

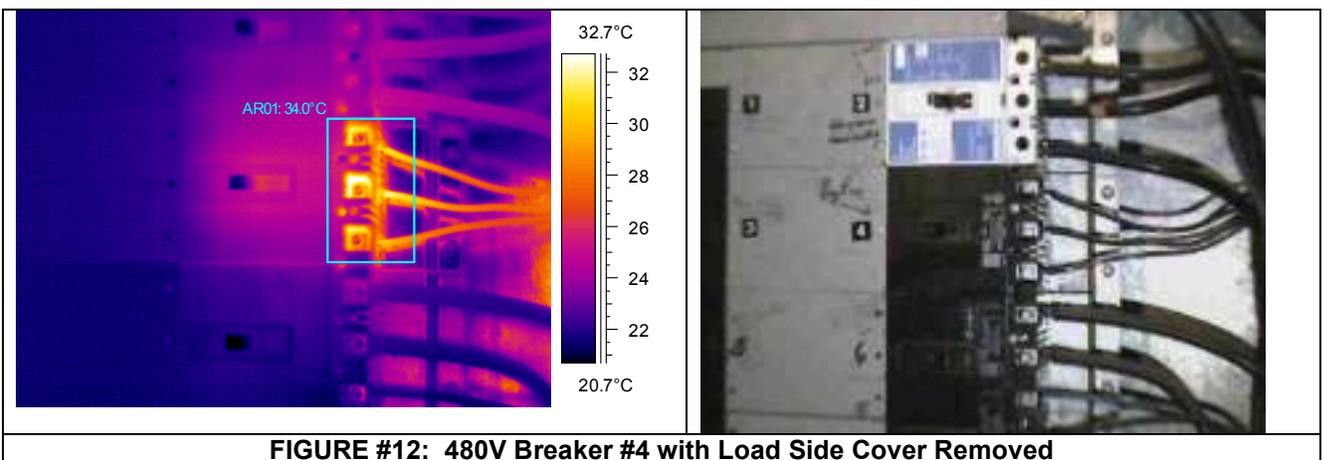
This image (Figure #12) shows that the contact temperature was about 10°C higher than what was shown on the surface of the breaker. Also, NO anomaly was shown on the outside of the cover itself. We decided to remove the buss side cover to investigate the other side.

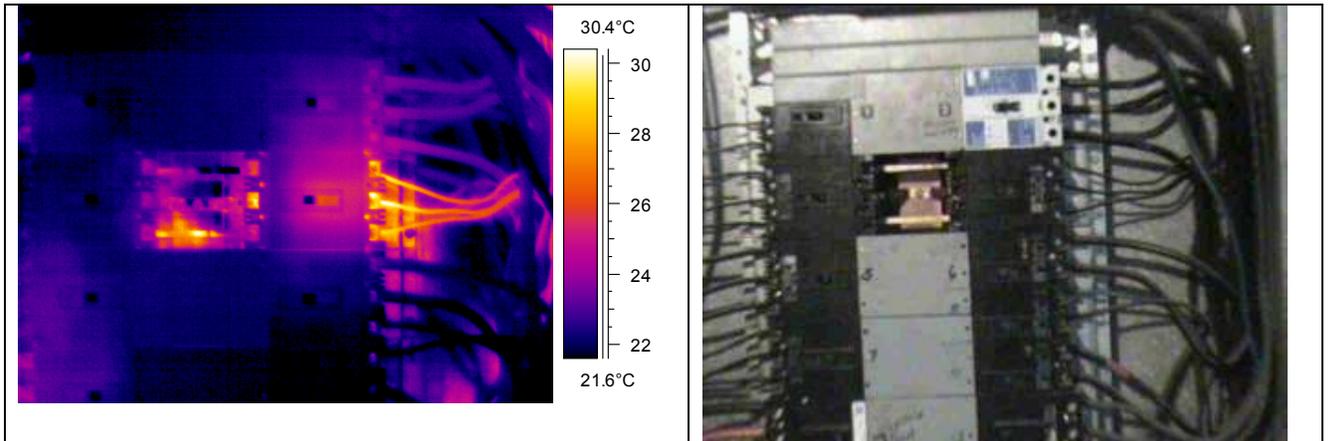
FIGURE #13: 480V Breaker with Buss and Load Side Cover Removed

With the load side cover removed (Figure #13), we noted a slight rise on the middle phase connection. The “issue” on the bottom phase buss was a reflection, but the connection was a true hot spot. It was at this point that we used our other tools available to get a voltage drop across the different connections and breaker contacts to determine where our issue was emanating from. With over a .275-millivolt drop across the B-phase contact of the breaker itself, we determined that Breaker #4 was in need of replacement.

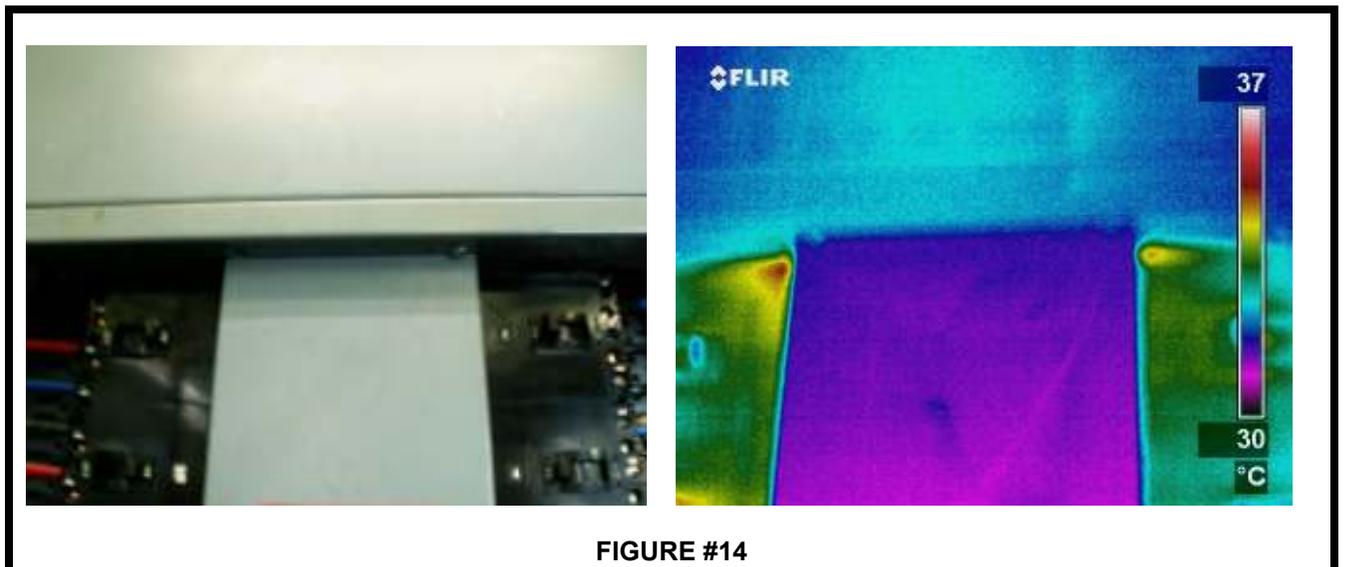
FIGURE #14

In one final example at a Medical Treatment Center in Fairbanks, Alaska, a Square D I-Line Panel rated at 800 amps was our target. Prior to performing any maintenance on the equipment, the customary Ultrasonic Airborne Safety Scan was performed and no anomalies were detected. As an additive safety precaution, we also conducted a brief IR scan with the camera on the exterior of the panel. The Digital and Infrared images are illustrated below in Figure #14:

As indicated in the images, there are no alarming thermal patterns on either the dead front cover (around 30 degrees C) or the main lug access cover. Some indications at the top corner of the dead front do illustrate some energy, but this could be merely load related heating effects. Once the dead front cover is removed, it is a bit more apparent that there is some type of heating occurring near the top of the panel, which is indicated in Figure #15 below:

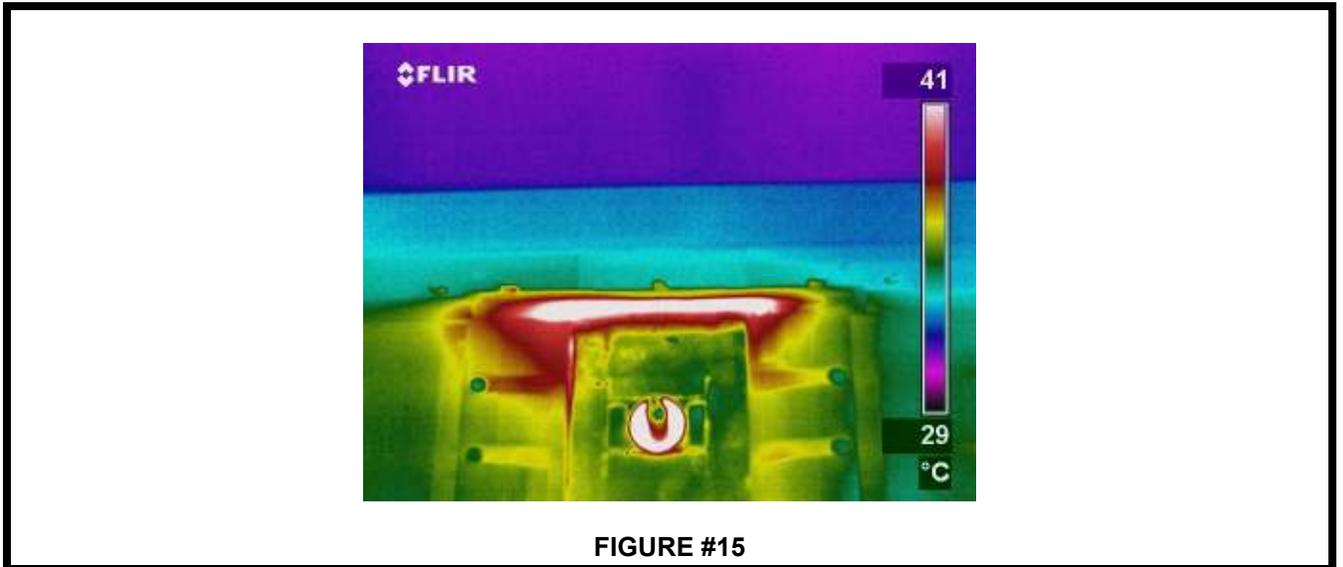
The image above certainly illustrates that there is something suspect within the panel (now the temperature is around 42 degrees C); however, it is still not conclusive as to the source or the severity of the condition contributing to the thermal emission we are observing. Once the top main lug access cover is removed for inspection, it becomes reasonably clear that there is a deficiency on the main lug connections illustrated in Figure #16, but where and which one(s)?

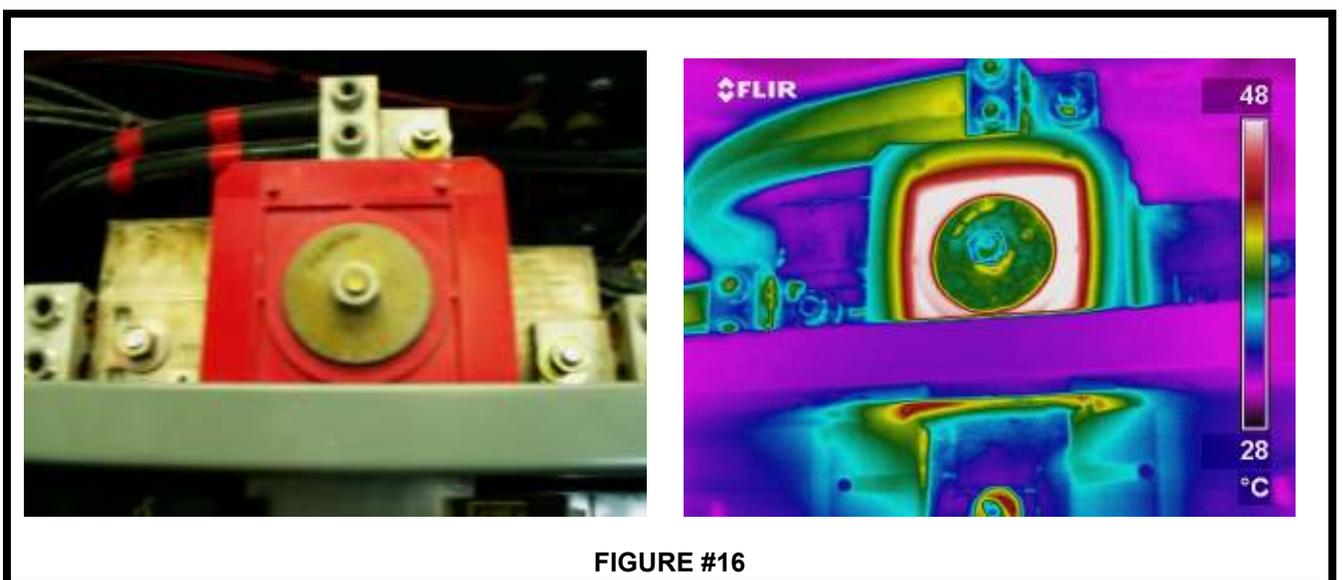
Even without the implementation of complete analysis procedures, it is evident that the problem is centered on the main lug assembly, and that the problem temperature is actually 53 degrees C. This is nearly a 22 degree C error in temperature with the covers on and with them removed. Additionally, terminations are rated at 65 degrees C absolute, and this 800 Amp panel had balanced loads of 450-460 amps. This represents only 50% of its rated capacity, and not all of the customer's loads were in use at the time of the visit. Once these additional loads are added, the problem temperature will then begin to increase exponentially, and it won't be long before it will exceed the 65 degrees C rating of the lugs. This will cause them to rapidly deteriorate and ultimately fail, possibly causing a fire and damage to other components.

Once this evidence was presented to the customer immediately while on site, authorization to perform the repairs was secured for 12:00 AM that evening. The panel was deenergized, the main lugs were disassembled, inspected, cleaned with emery cloth, new hardware was used to reinstall it, the toggle bolt was torqued to Square D's specifications, and the panel was returned to service.

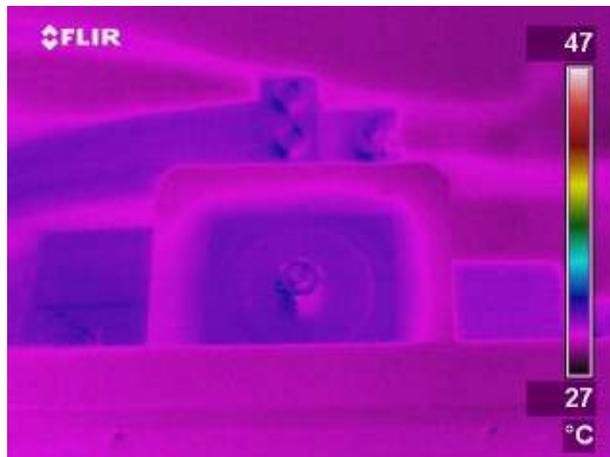
FIGURE #17

At this point the job is completed, right? Wrong! We must ALWAYS return to verify any repairs we perform, particularly on agreements where they are guaranteed, using the IR camera to provide an illustration of how effective repairs were. In this case, you can see below in Figure #17 that they were extremely successful when returned to service. Under the same operating conditions, the "problem" temperature was reduced by nearly 25 degrees C, and is well within acceptable operating parameters.
