Infrared Inspections on Electric Panels without Removing Covers: Can the Inspection be Completed Correctly?

*Joe Gierlach, Director, Technical Training and Support, TEGG Corporation
Joe DeMonte Senior Thermography Course Instructor*

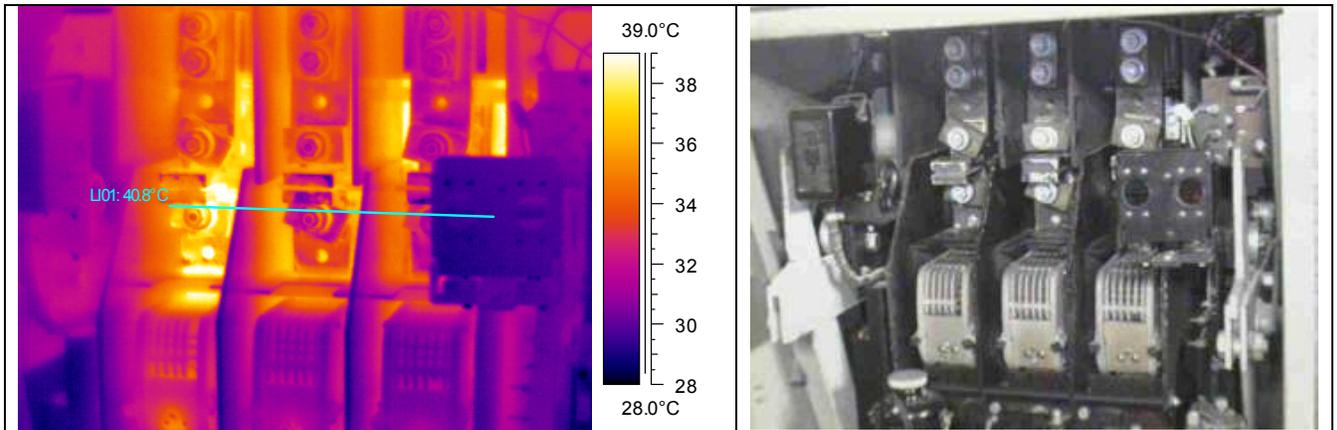
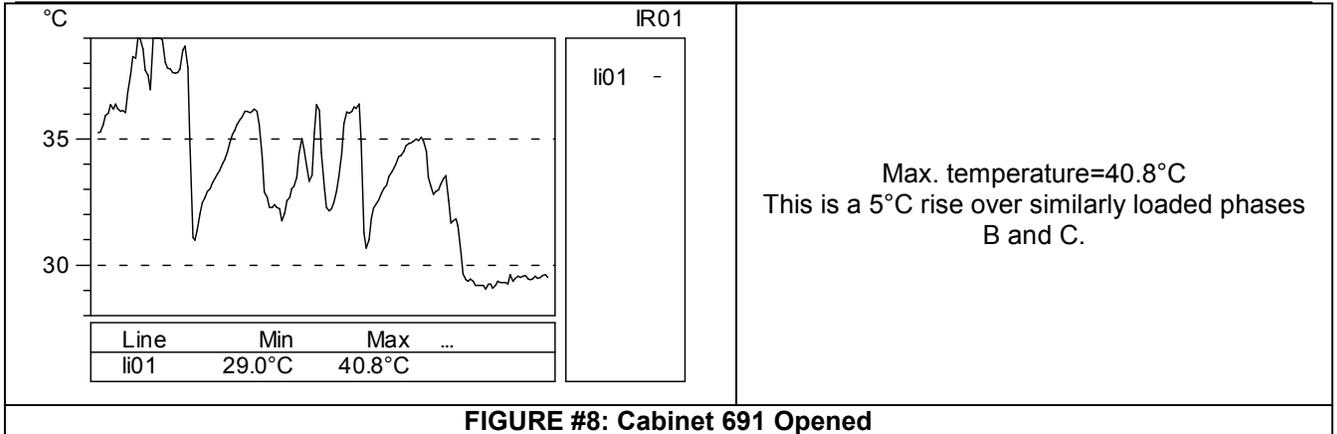
FIGURE #7: Cabinet 692 Opened

The cause of the heat on the warmer 692 cabinet was load related. Cabinet 691 actually had an anomaly that would have gone undetected by not properly removing the cover during the inspection. Also, the fact that this anomaly was found at approximately 10% of the system's rated load shows how a fairly important problem could have been overlooked. Once the load is increased, the heat generated by the fault will increase exponentially. Our calculations would have this rise increase to approximately 110°C when the transformer was under 80% load.
